HURRICANE ENGINEERING & TESTING INC.

REPORT NUMBER: **HETI-03-1350**
MANUFACTURER: RC Aluminum Industries, Inc.
2805 NW 75th Avenue, Miami, Florida 33122

PRODUCT: Mulled Picture & Casement Window

MODEL: CM100

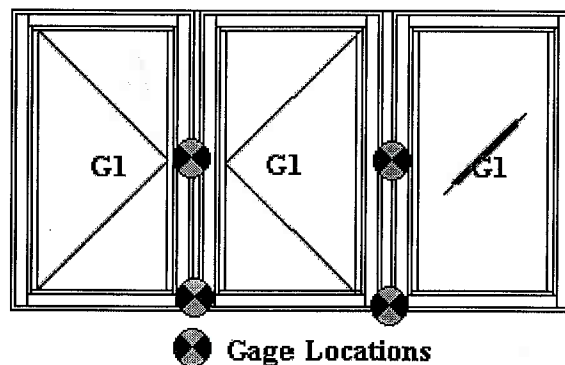
- Model designation:** CM100.
- Overall size** 111" w x 74 1/4" h (overall frame size)
- Configuration** XXO (See Figure on page one).
- No. & size of vents** (3) Fix Vent 37" w x 74 1/4" h , Operable Vents 35 3/8" x 72 3/4"
